Manhole Inspection Summary

Manhole # S49CC_014MH

Insp Date: **2/14/08 10:19 AM**

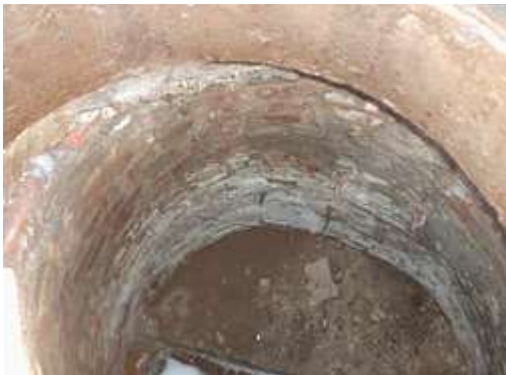
Defect 2

Count: **3** Missing: **3** ☐ Corroded

Missing Steps

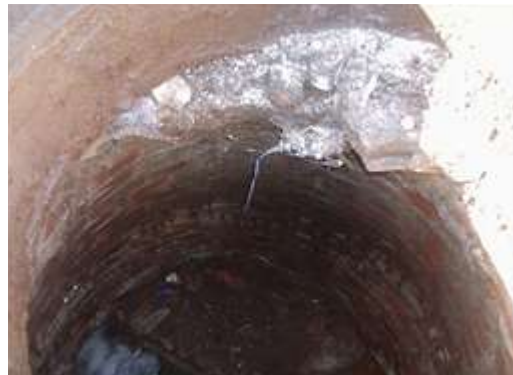
Defect 1

Adjustment Joints

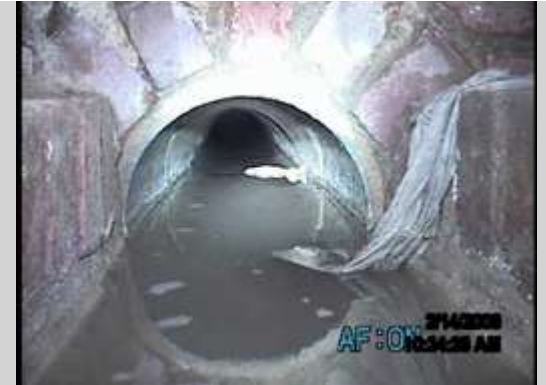
12 O'Clock Outflow

Pipe Height: **8.4** (in.) Rod and Bar (Angled)
Pipe Material: **Clay** ☐ Pipe Lined
Invert Depth: **6.80** (ft.) Flow Characteristics: **Slow**
Deposits: ☒ None ☐ Mud ☐ Sludge ☐ Debris ☐ Grease
Silt Depth: (in.) Deposits Extent:
Infiltration: **None** Pipe Seal Cond: **Sound**

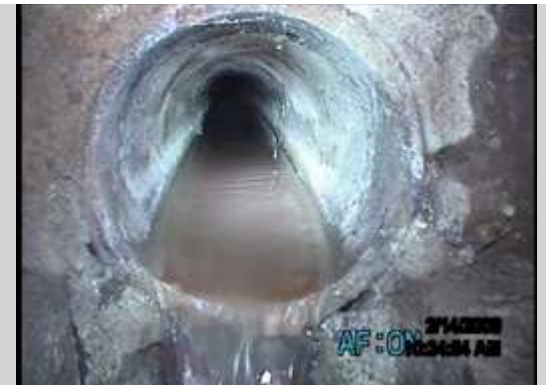
2 O'Clock Inflow

Pipe Height: **8.4** (in.) Rod and Bar (Angled)
Pipe Material: **Clay** ☐ Pipe Lined
Invert Depth: **6.60** (ft.) Flow Characteristics: **Slow**
Deposits: ☒ None ☐ Mud ☐ Sludge ☐ Debris ☐ Grease
Silt Depth: (in.) Deposits Extent:
Infiltration: **None** Pipe Seal Cond: **Sound**

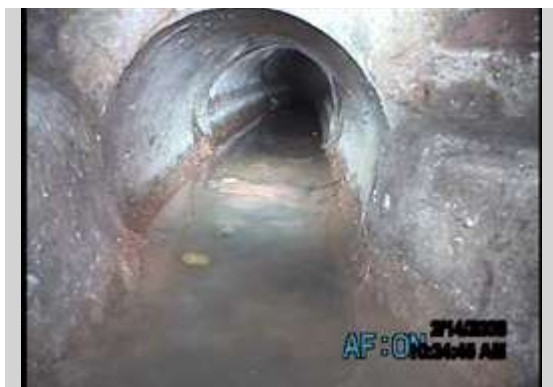
7 O'Clock Inflow

Infiltration: **None** Pipe Seal Cond: **Sound**
